Reserve Study Update Long Point POA Savannah, Georgia

Prepared for FY 2024
Report Date: March 23, 2024

Re: Long Point POA

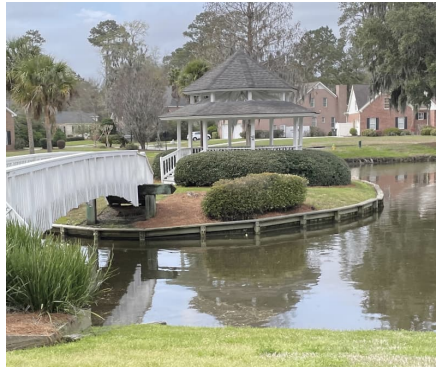
Flooring and trim replacement

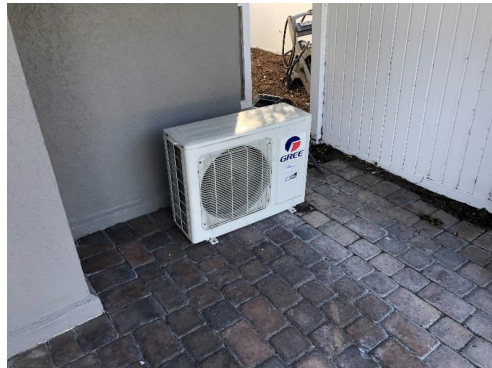
- Heat pump at Guardhouse age unknown, projected replacement FY 2024.
- Guardhouse interior refurbishment allowance included.

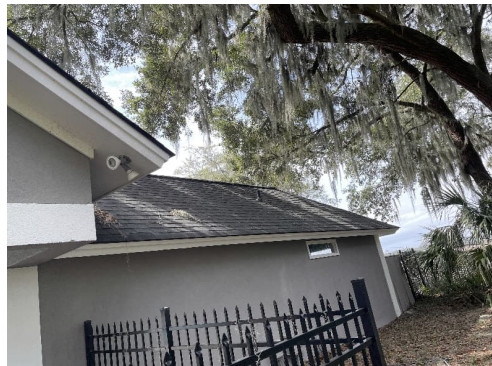
Asphalt Shingles - Pool Cabana - 2027

- From ground level observation shingles appear in fair condition. Recommend roof top inspection and repair annually of shingle roofs.

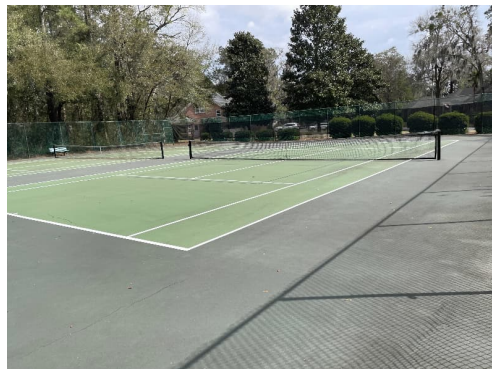
Asphalt Resurface (color coat) - 2027

- Courts are in good condition with replacement projected in FY 2037.

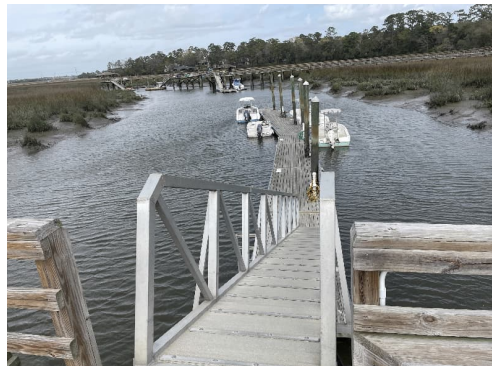
Floating Piers - 2032

- All piers and docks appear in good condition. Recommend annual inspection and repair by qualified contractor.
