Reserve Study Update Long Point POA Savannah, Georgia

Prepared for FY 2024
Report Date: March 23, 2024

Re: Long Point POA

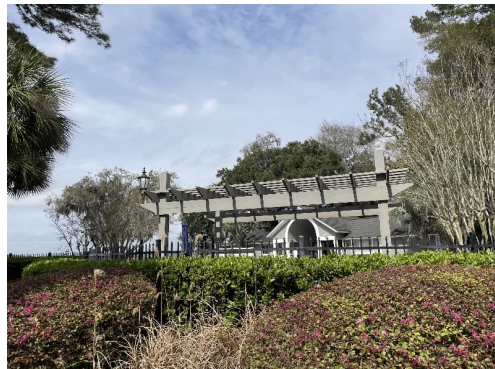
Wood Pergola - 2040

2 Each	@ \$3,200.00
Asset ID	1054	Asset Actual Cost	\$6,400.00
		Percent Replacement	100%
Category	Swimming Pool	Future Cost	\$11,097.51
Placed in Service	January 2021		
Useful Life	20		
Replacement Year	40-41		
Remaining Life	16

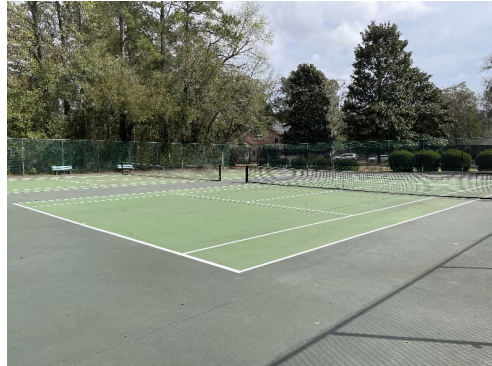
Asphalt Replacement - 2037

Asset ID	1064	1,436 Square Yards	@ \$68.00
Category	Tennis Courts	Asset Actual Cost	\$97,648.00
Placed in Service	January 2008	Percent Replacement	100%
Useful Life	30	Future Cost	\$152,717.18
Replacement Year	37-38		
Remaining Life	13

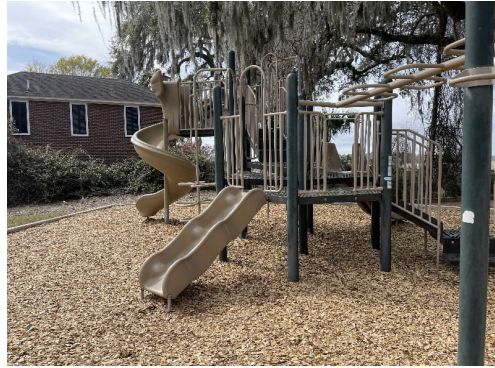
Play Equipment Allowance - 2028

Asset ID	1066	1 Lump Sum	@ \$25,000.00
		Asset Actual Cost	\$25,000.00
		Percent Replacement	100%
Category	Playground	Future Cost	\$28,688.07
Placed in Service	January 2008		
Useful Life	15		
Adjustment	6		
Replacement Year	28-29		
Remaining Life	4

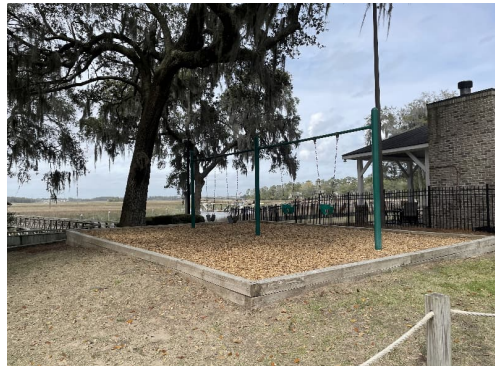
Swings Post - Two Bay - 2028

Asset ID	1065	1 Each	@ \$5,300.00
		Asset Actual Cost	\$5,300.00
		Percent Replacement	100%
Category	Playground	Future Cost	\$6,081.87
Placed in Service	January 2008		
Useful Life	15		
Adjustment	6		
Replacement Year	28-29		
Remaining Life	4

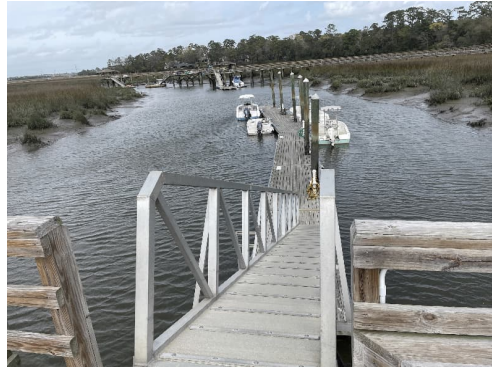
Aluminum Gangways - 2052

Asset ID	1078	2 Each	@ \$3,000.00
		Asset Actual Cost	\$6,000.00
		Percent Replacement	100%
Category	Marina Components	Future Cost	\$15,721.03
Placed in Service	January 2018		
Useful Life	35		
Replacement Year	52-53		
Remaining Life	28

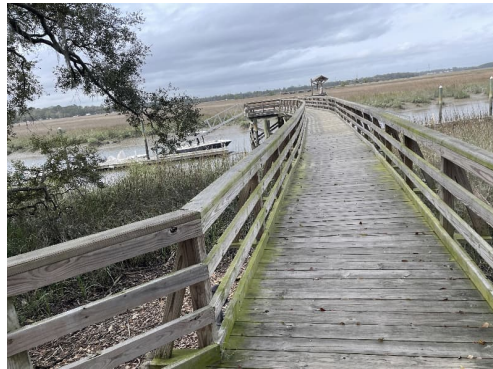
Wood Deck/Stringers/Rails Misc.Repair (annual) - 2024

Asset ID	1077	1 Lump Sum	@ \$2,000.00
		Asset Actual Cost	\$2,000.00
		Percent Replacement	100%
Category	Marina Components	Future Cost	\$2,000.00
Placed in Service	January 2020		
Useful Life	1		
Adjustment	2		
Replacement Year	24-25		
Remaining Life	0

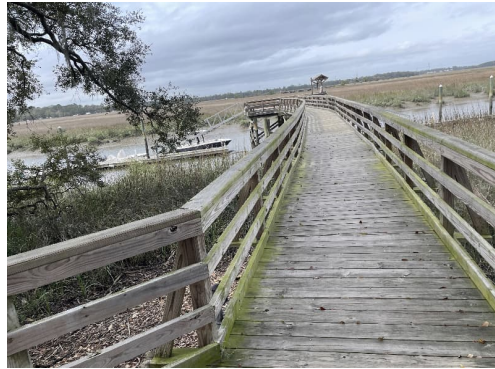
Wood Pier Replacement Allowance continued...

Asset ID	1076	1,260 Square Feet	@ \$74.00
		Asset Actual Cost	\$93,240.00
		Percent Replacement	100%
Category	Marina Components	Future Cost	\$173,192.29
Placed in Service	January 2018		
Useful Life	25		
Replacement Year	42-43		
Remaining Life	18

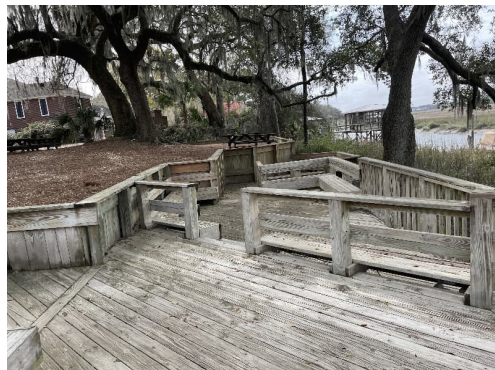
Wood Walks - Pier Approach - 2032

820 Square Feet	@ \$39.00
Asset ID	1081	Asset Actual Cost	\$31,980.00
Category	Marina Components	Percent Replacement	100%
Placed in Service	January 2008	Future Cost	\$42,111.55
Useful Life	25		
Replacement Year	32-33		
Remaining Life	8

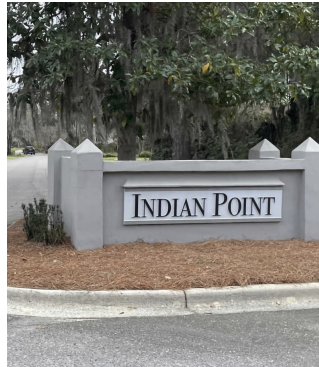
Repair/Paint - Community Signs continued...

Asset ID	1082	Asset Actual Cost	
Category	Operating Expense	Percent Replacement	100%
Placed in Service	January 2008	Future Cost	
No Useful Life

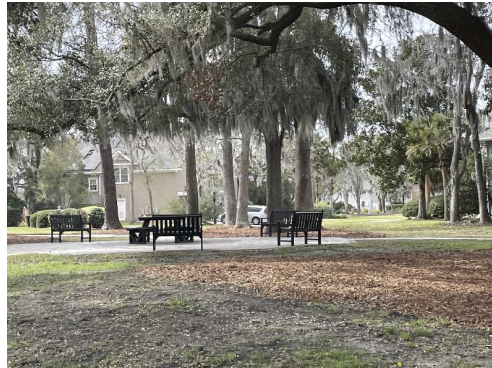
Concrete Paver - Indian Point Park

Asset ID	1084	Asset Actual Cost	
		Percent Replacement	100%
Category	Long Life Components	Future Cost	
Placed in Service	January 2022		
No Useful Life

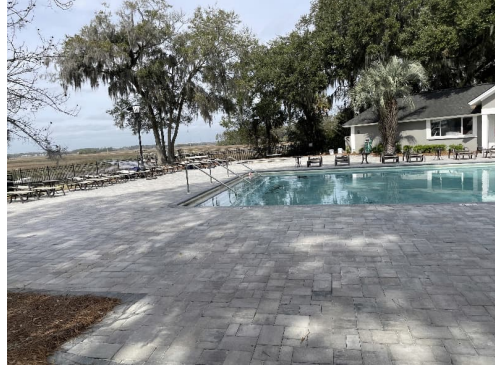
Concrete Pavers - Pool Deck

Asset ID	1056	Asset Actual Cost	
Category	Long Life Components	Percent Replacement	100%
Placed in Service	January 2021	Future Cost	
No Useful Life

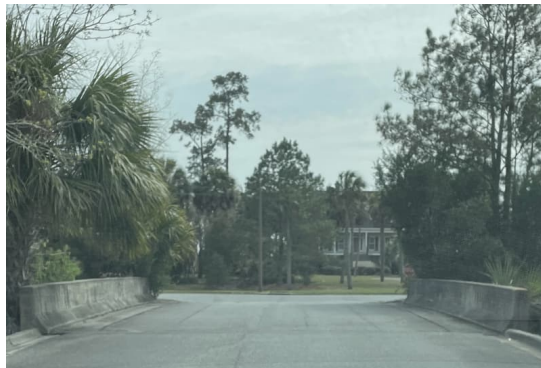
Concrete Vehicle Bridges - Key Island Drive

Asset ID	1068	Asset Actual Cost	
Category	Long Life Components	Percent Replacement	100%
Placed in Service	January 2008	Future Cost	
No Useful Life

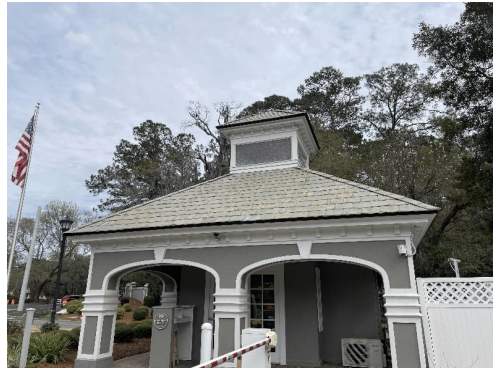
Slate Roofing - Guardhouse

Asset ID	1049	Asset Actual Cost	
Category	Long Life Components	Percent Replacement	100%
Placed in Service	January 2008	Future Cost	
No Useful Life
